ROUND ISLAND LIGHT HOUSE
RESTORATION
DETAIL SHEET
SHEET 4

DATE: AUGUST 1995
PREPARED BY: COMPTON ENGINEERING PA
PASCAGOULA, MISSISSIPPI

RLH3

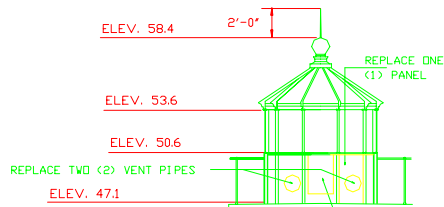
LANTERN INTERIOR & DECK

- FINISH SCHEDULE**
(AFTER REPAIRS ARE COMPLETED)
- 1 SANDBLAST ALL INT. METALS
 - 2 ON ALL IRON MATERIAL, APPLY TWO (2) COATS OF INTERIOR EPOXY SEMI-GLOSS PAINT
 - 3 ALL COPPER MATERIALS TO BE LEFT UNPAINTED
 - 4 APPLY A NON-SKID PAINT COATING TO INSIDE DECK SURFACE
